TBM Drives at the Gotthard Base Tunnel

Challenges in the Faido section

Thomas Jesel, MSc, Amberg Engineering AG

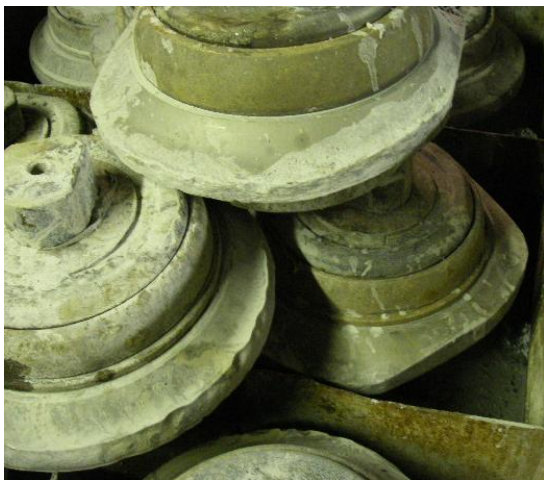
Cutter head wear I

- Abrasivity with Cherchar index
- Tender design: CAI 2.8
- Medelser Granite CAI 4.4
- Lucomagno Gneiss CAI 3.4

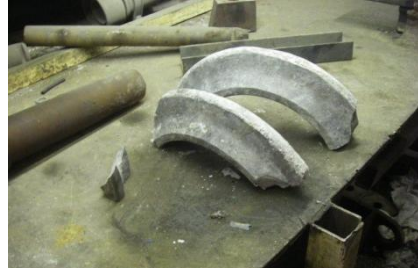
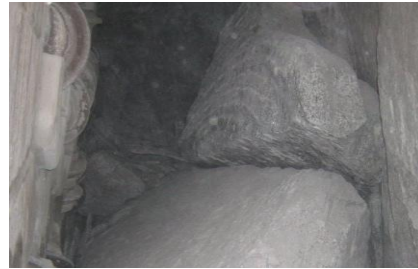
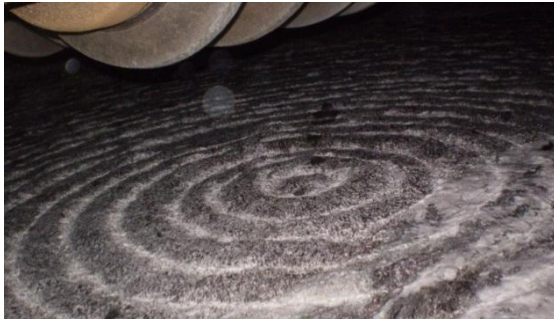
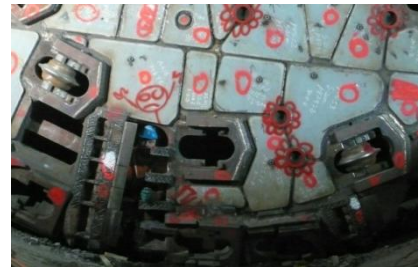
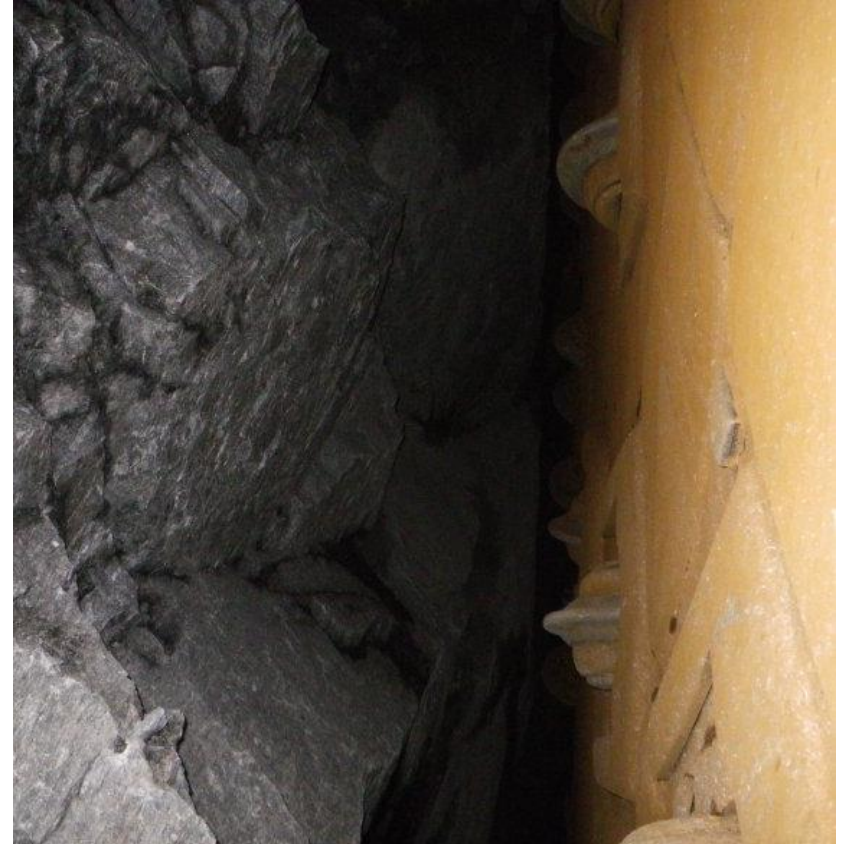
Cutter head wear II

- Instable face
- Not all discs at face
- Reduced face pressure
- Reduced cutting speed
- Blocks at the face
- Cutter head as crusher
- Rolling blocks hits the disks

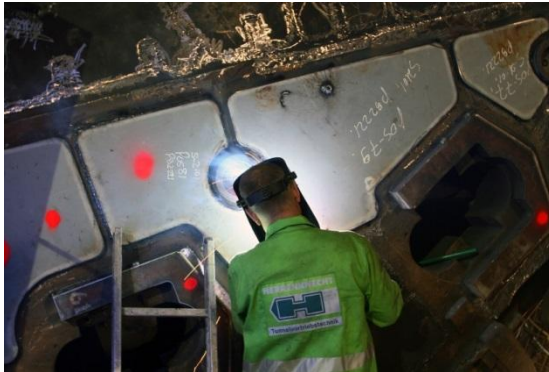
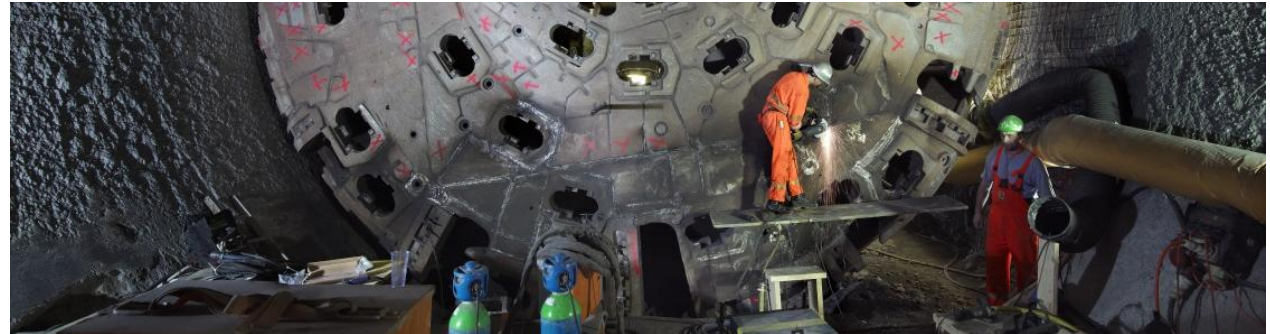
Cutter head wear III

- CAI much higher than prognosis
 - Damaged Disks due to blocks
 - Often longer maintenance shifts
 - Reduced pressure due to instable face
- Determinating for advance rate

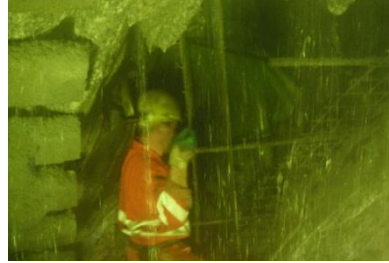
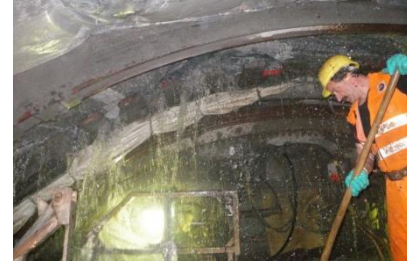
Water inflow II

- Water inflow initial max 100 l/s
- Ascending tunnel
- 600 mm drainage pipe
- No problem
- But 48°C!
- Cooling system limited
- Reduced working hours
- Frequent pauses required
- Reduced advance rate

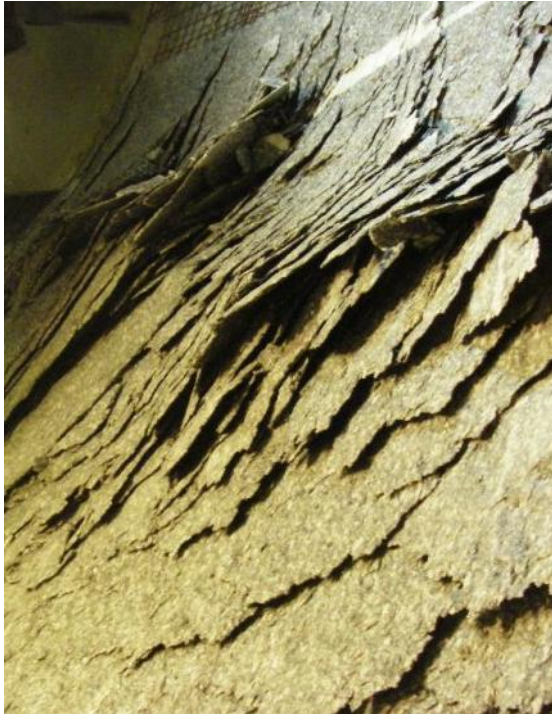
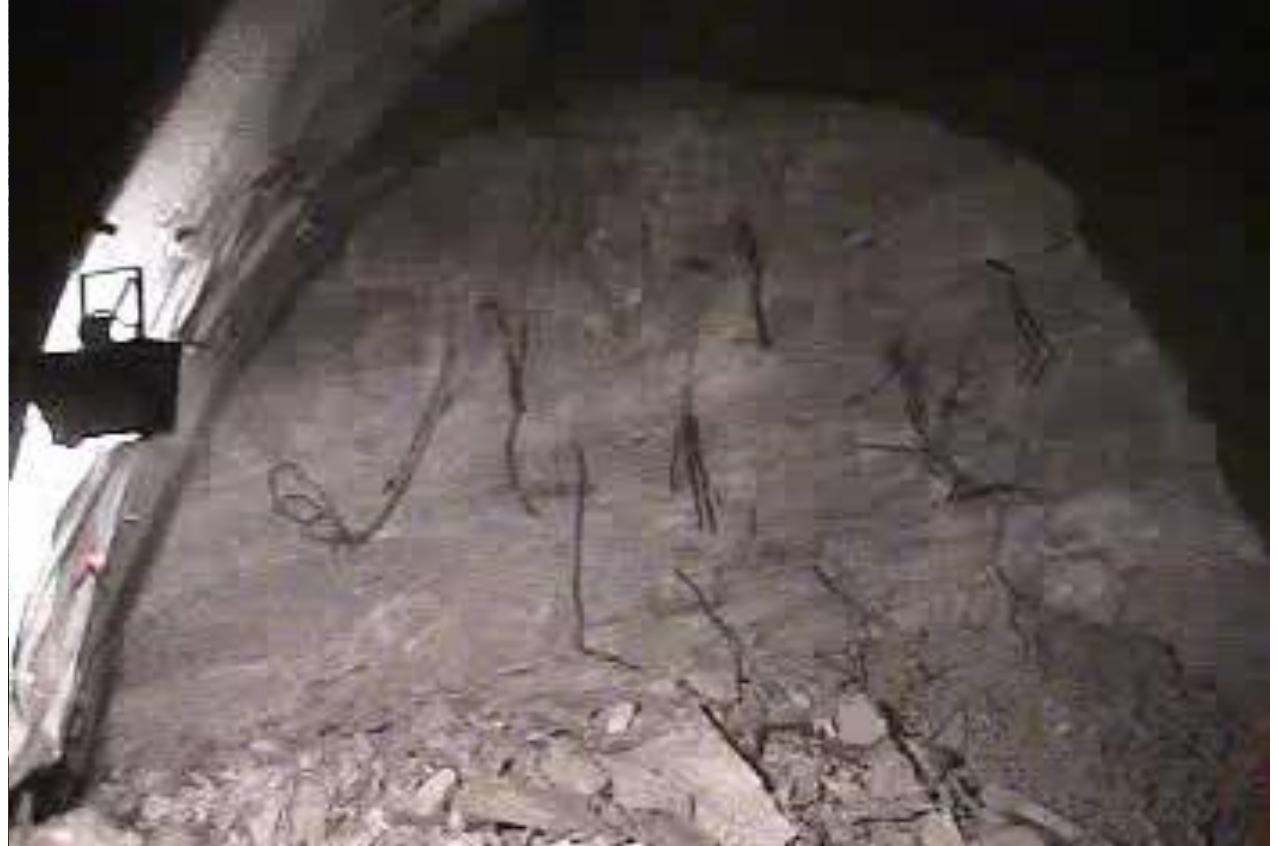
Rock burst I

- Difficult to predict
- Without warning – suddenly!
- Rock support cannot prevent rock burst
- But must protect staff TBM helps!
- Absorb kinetic energy
- Not easy to classify, subjective
- Code of classification
- Potential measures

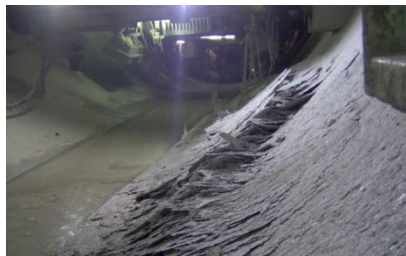
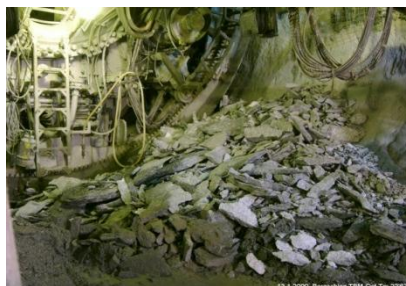
Rock burst II

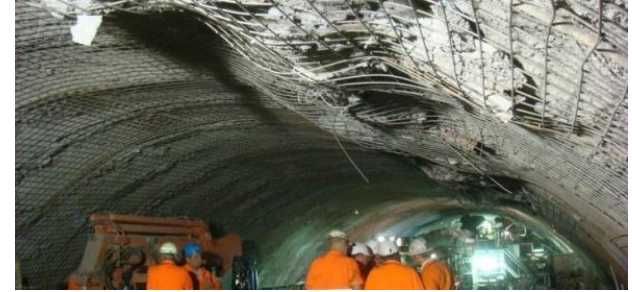
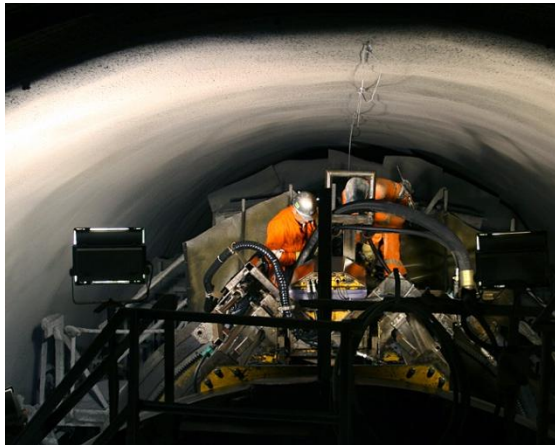
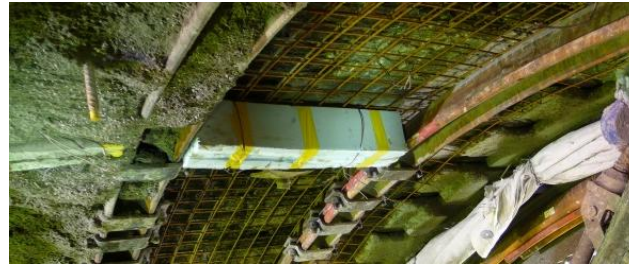
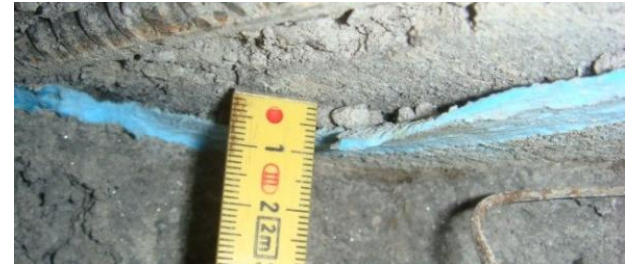
Squeezing rock I

- Started with Steel arches and rock bolts and shotcrete
- Soon deformations (30 cm)
- Shotcrete destroyed
- Steel arches plastified

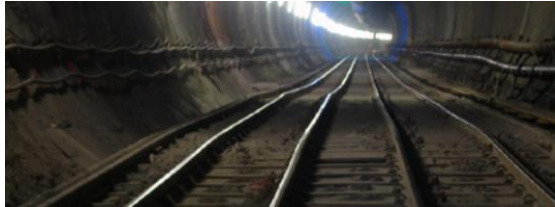
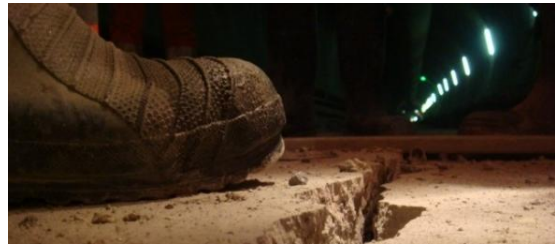
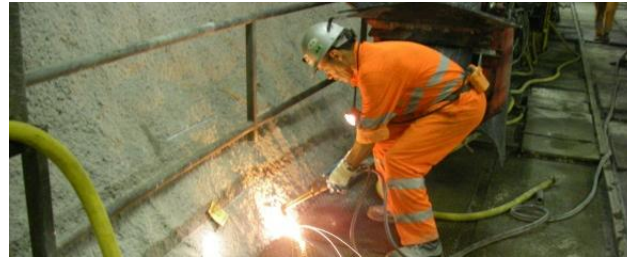
Squeezing rock II

- Second TBM even worse
- Back up was squeezed in
- Heave in the invert
- Reconstruction of the invert still under the TBM

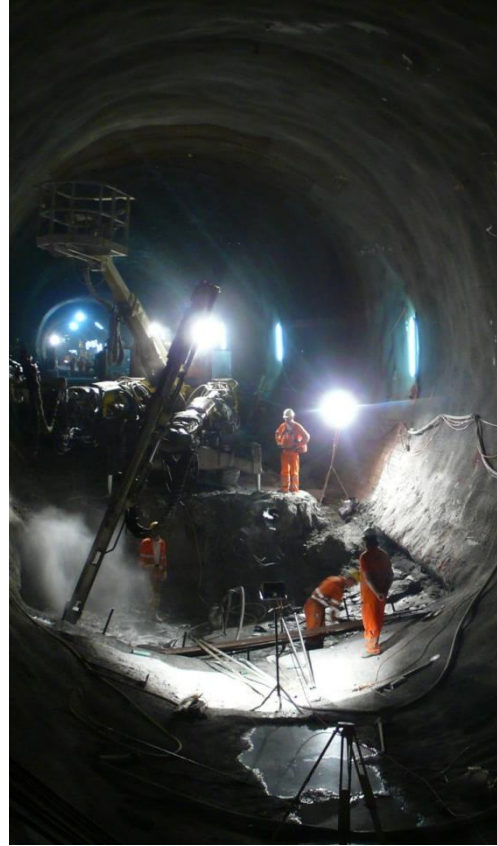
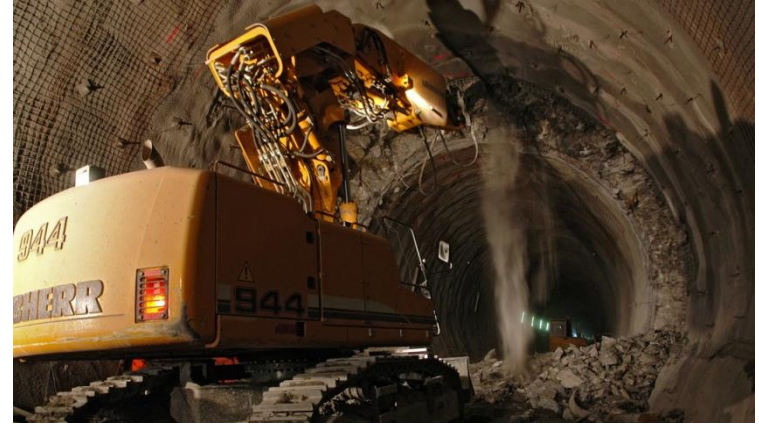
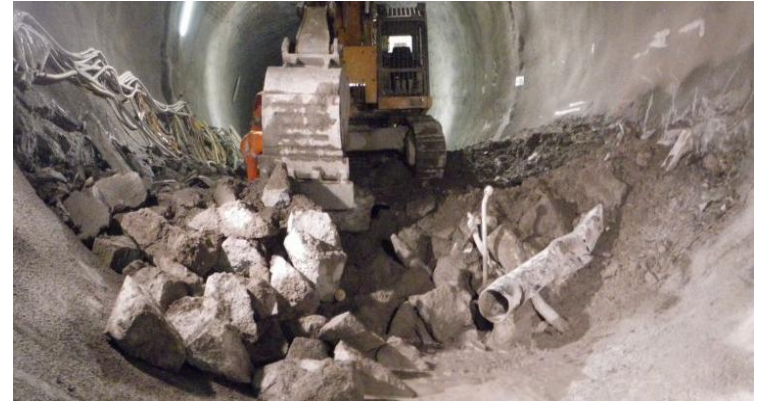
Squeezing rock III

- TBM got through – at the end
- Intensive back calculations
- New loads, new design
- Tunnel redone on 400 m

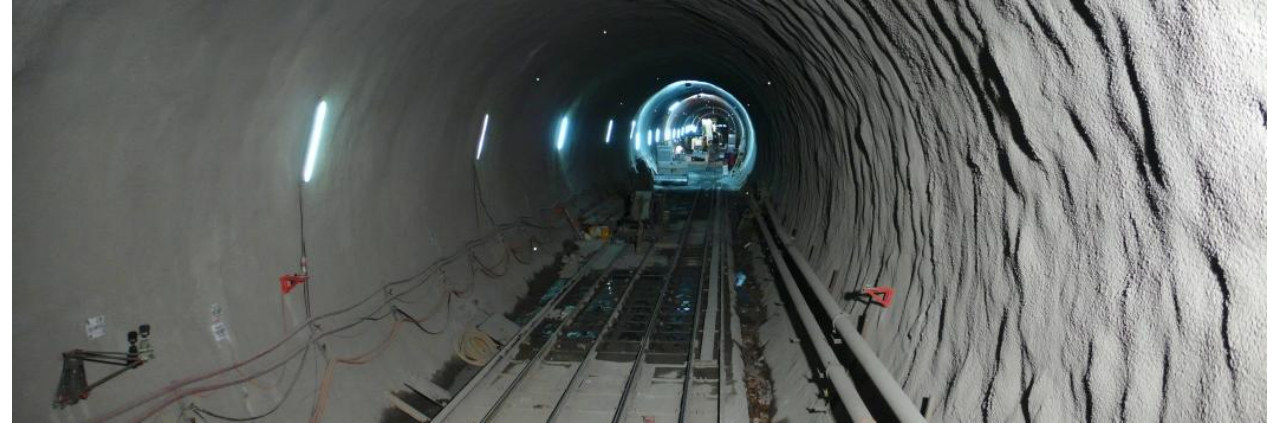
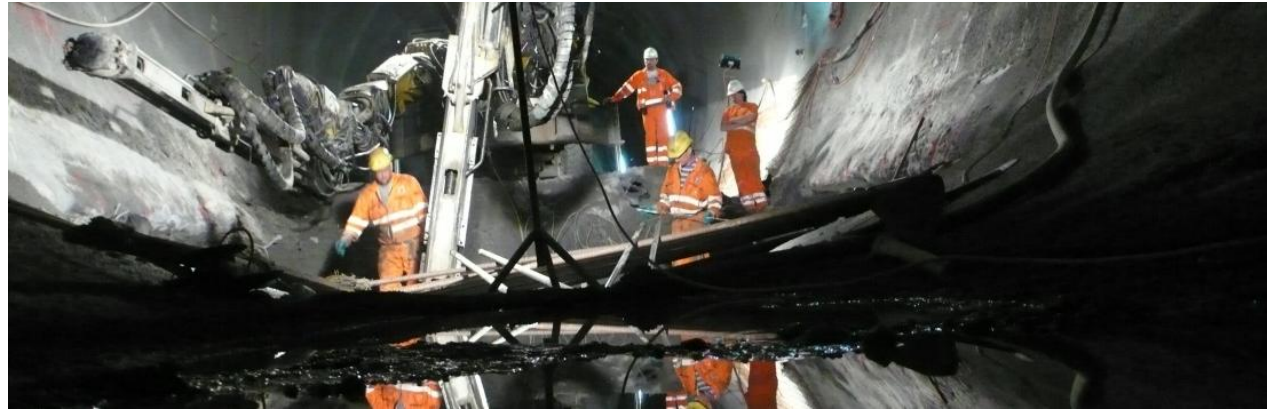
Squeezing rock IV

- D&B in this area had less problems
- Rock support can be installed direct at the front, with TBM not possible
- Distance between face and installed rock support is important
- Shield must be as short as possible
- Styrofoam elements worked well to protect young shotcrete
- Inclined cross passages allowed to redo the tunnels without interrupting the TBM

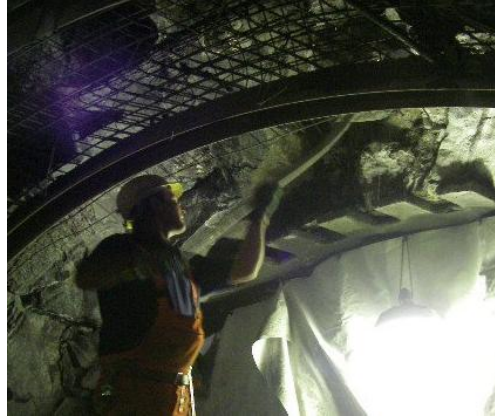
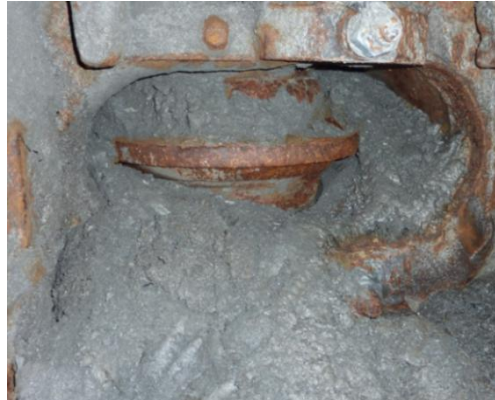
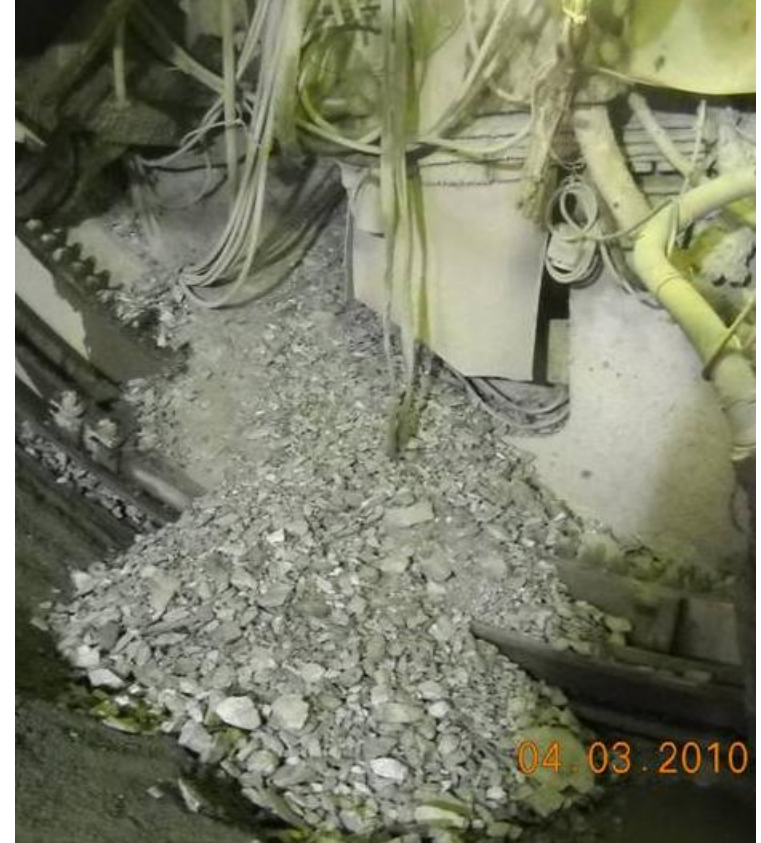
Blocked TBM I

- First machine passed
- Some over brake
- Second machine got stocked
- Several attempts with backing and restart were not successful
- 1'100 m spiles installed
- Voids filled up with 48 m³ concrete and 47 m³ grout

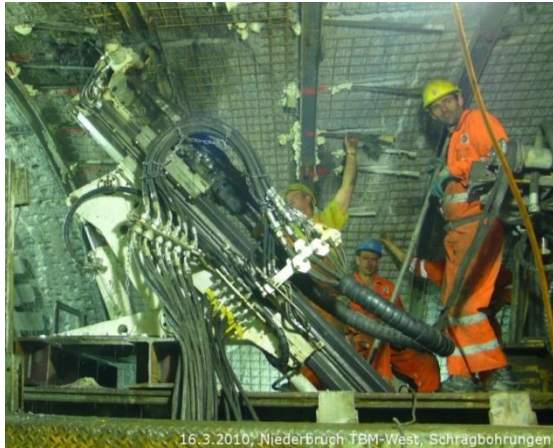
Blocked TBM II

- Still not successful
- A lot of material was taken out without any progress
- Massive cavern above tunnel
- Extensive probe drilling

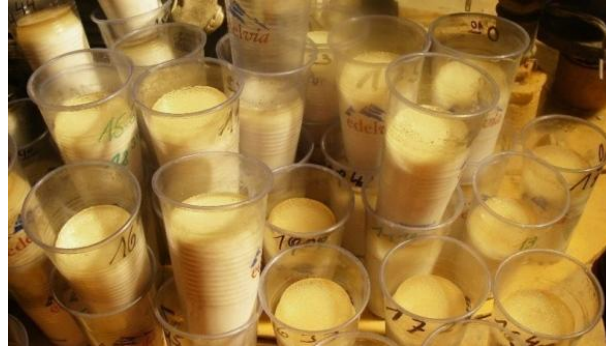
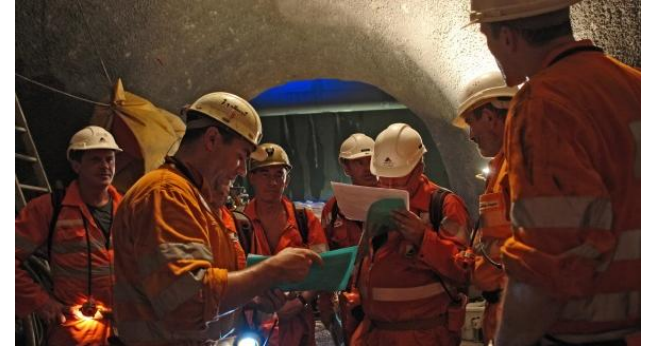
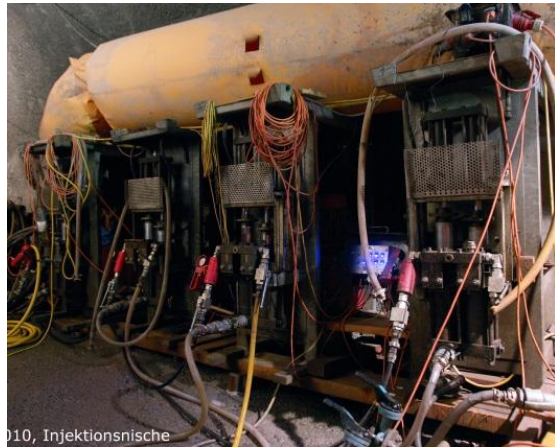
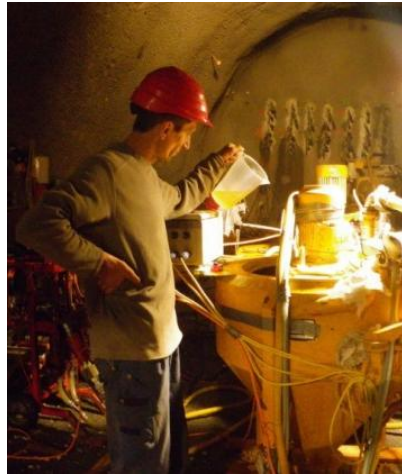
Blocked TBM III

- Stabilize loos material
- Grouting campaign from a niche, east tunnel
- Counter heading to secure the time schedule

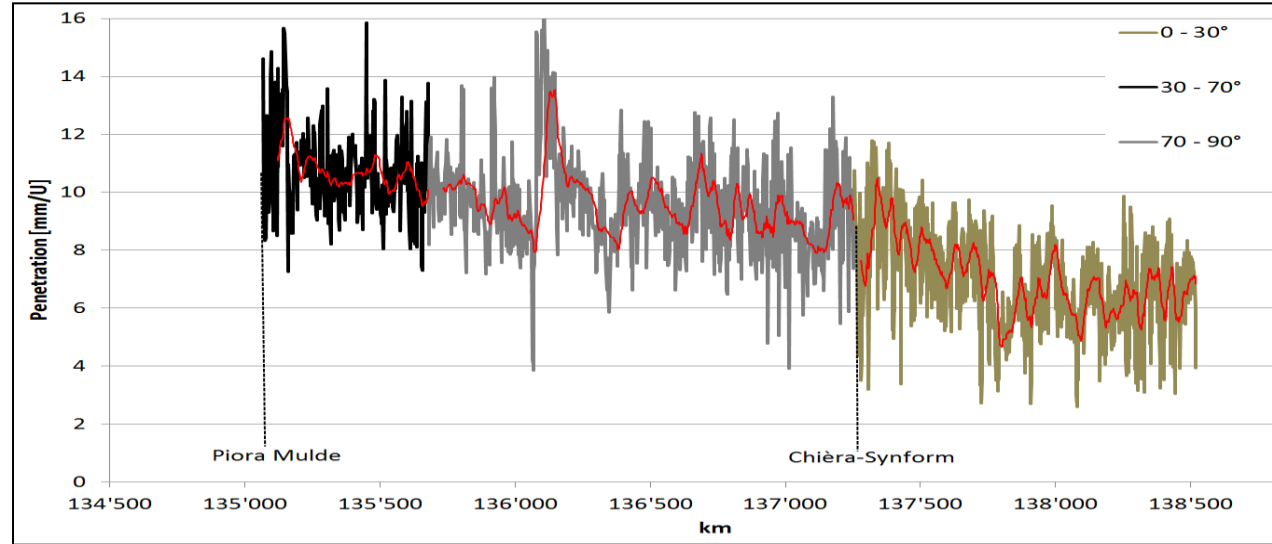
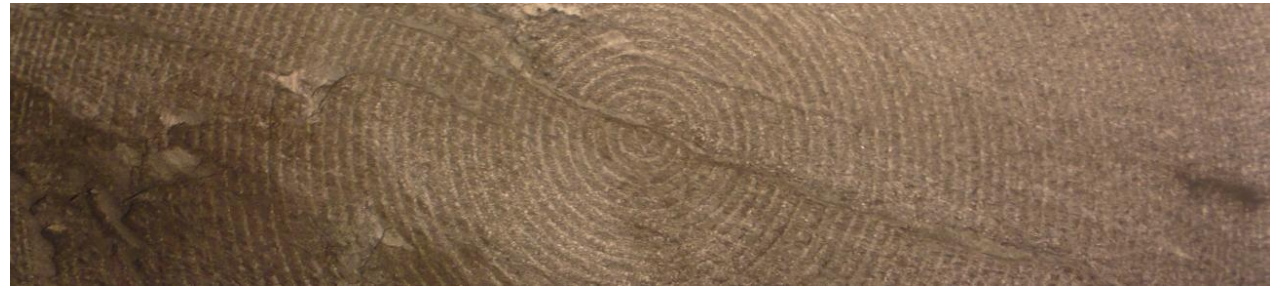
Advance rates II

- Joint and foliation angle important influence
- Penetration around 10 mm while perpendicular
- Drops down to 70% while flat

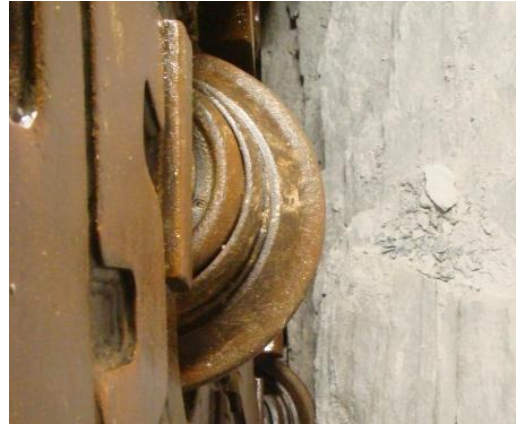
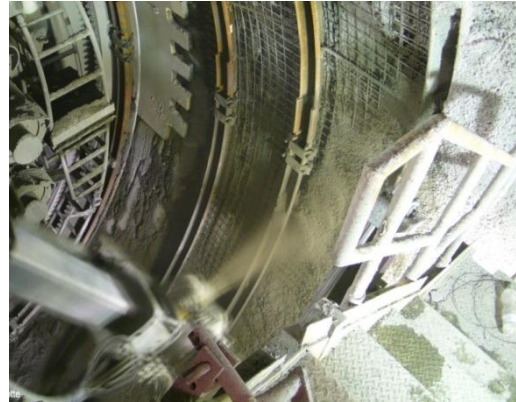
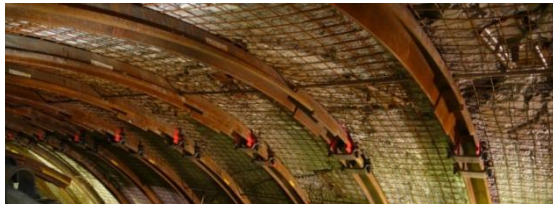
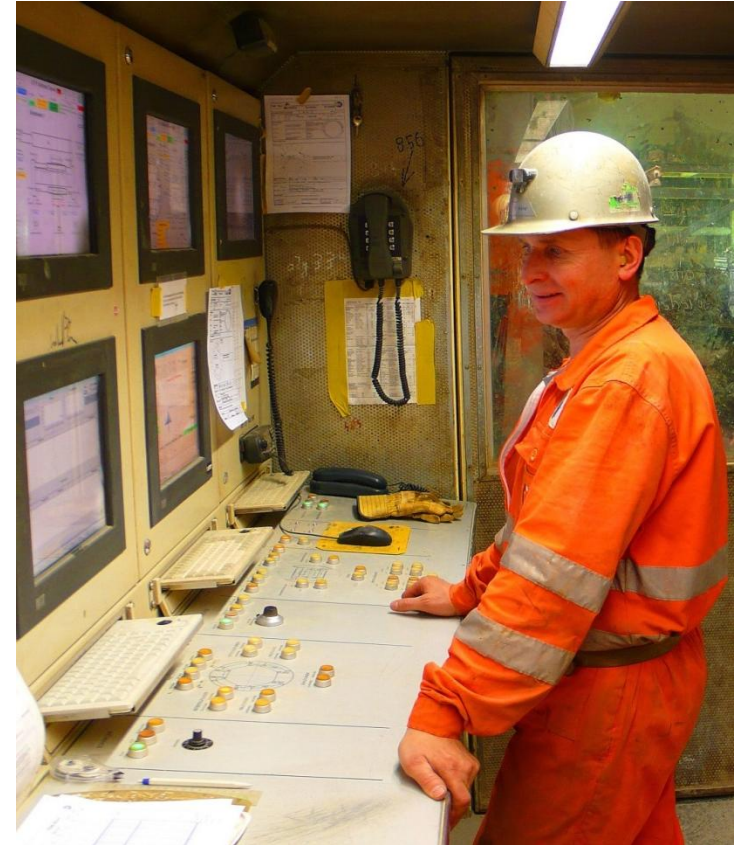
Lessons learned I

- Optimize TBM for most probable geology – set right focus
- Make sure, that TBM can handle worst case
- Open gripper TBM was right decision - flexibility was needed
- Shotcrete in L1 was necessary and feasible, main shotcrete in L2
- Rock bolts in L2 were not used. Bolts are needed as close to the face as possible
